## INVESTIGASI STRUKTUR NAVIGASI YANG RUNTUH DI DELTA SUNGAI MAHAKAM MENGGUNAKAN BATIMETRI DAN SONAR

### INVESTIGATION FOR COLLAPSED NAVIGATION STRUCTURES IN THE MAHAKAM RIVER DELTA BY BATHYMETRY AND SONAR

Aco Wahyudi Efendi

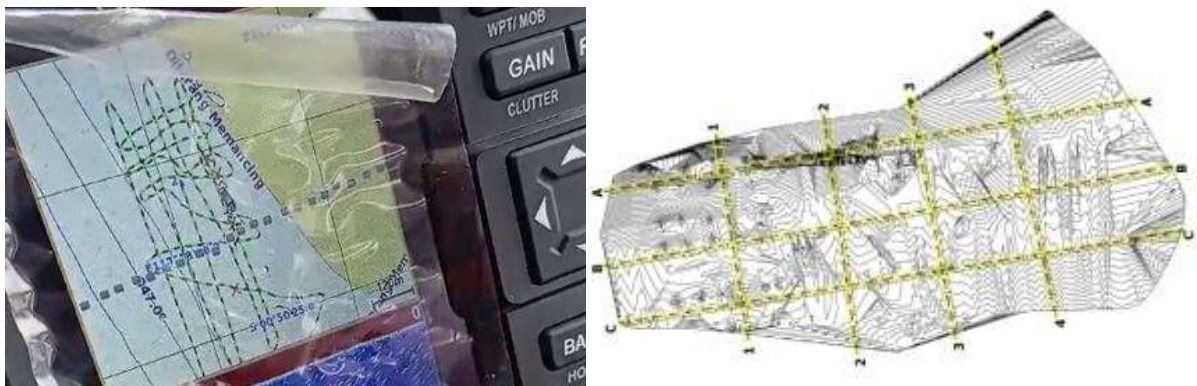
Figure 8. Identification Location

The bathymetric DTMs revealed localized depressions and irregular features on the seafloor that deviated from the natural riverbed topography. These features, often characterized by sharp edges and distinct profiles, indicated the presence of submerged objects. For instance, one significant anomaly (Figure 1a) showed a sudden depth change of approximately 3 meters over a small area, suggesting a prominent upright or partially collapsed structure.

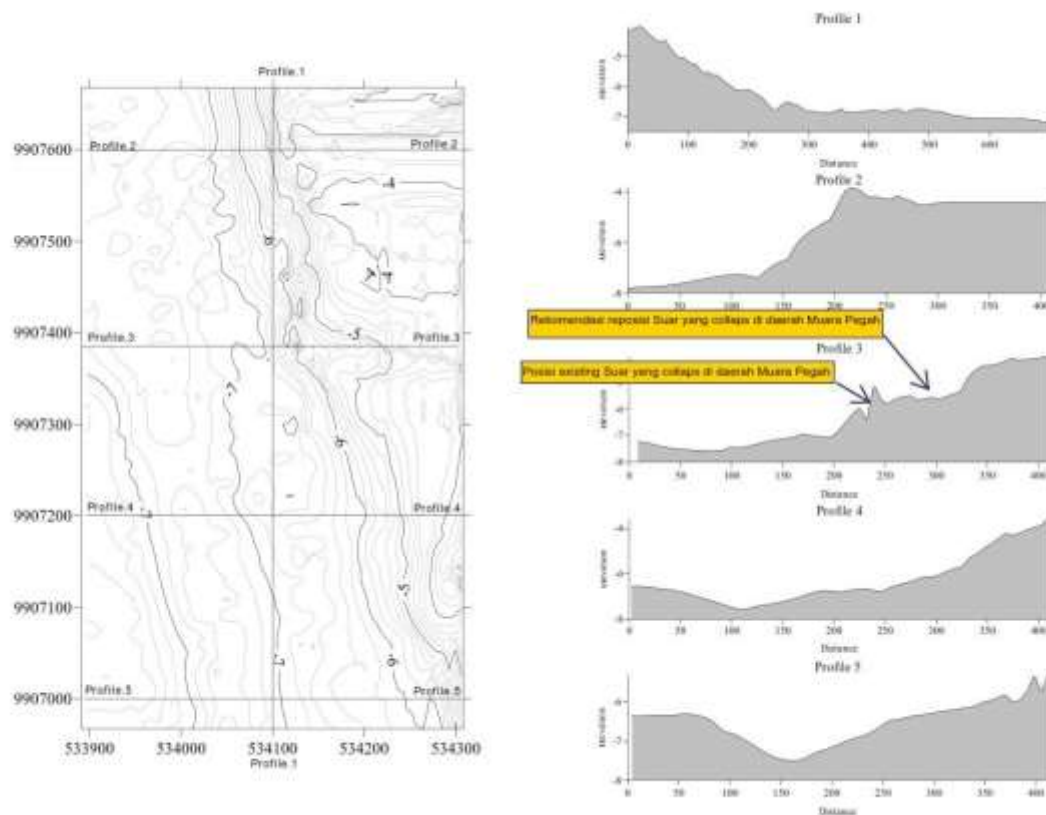
Figure 9. Building indications

Based on the provided bathymetric data, Figure 9, encompassing contour maps and cross-sectional profiles, provides a comprehensive view of the riverbed. Profile 3 clearly indicates a distinct anomaly labeled "Posisi exsisting Suar yang colaps di daerah Muara Pegah," confirming a collapsed beacon via an irregular depression. Complementary sonar imagery further supports this finding with acoustic returns at approximately 4.5 meters depth. The presence of this identified collapsed beacon at Muara Pegah poses a significant navigational hazard. Consequently, the survey not only pinpoints its exact location but also provides a "Rekomendasi relokasi Suar yang colaps," suggesting a safer alternative site on Profile 3. This holistic approach, from detection to relocation recommendation, is crucial for enhancing maritime safety and optimizing infrastructure in the Mahakam River Delta.

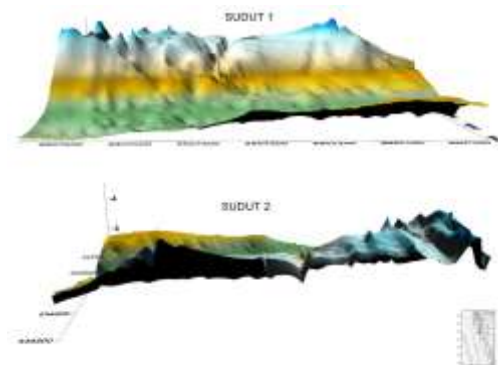
Figure 10. 3D view of Sonar results

The side-scan sonar mosaics provided detailed acoustic imagery of these anomalies. Objects appeared as bright returns with distinct acoustic shadows, clearly distinguishing them from the surrounding sediment. Figure 1b, corresponding to the bathymetric anomaly, clearly depicts a rectangular shape with a prominent shadow, consistent with a collapsed beacon or a large part of a navigation structure. The resolution of the side-scan sonar allowed for the identification of potential structural components.

Detailed 3D bathymetric models (Figures SUDUT 1 & 2) reveal a significant, 1-1.5m high elevation anomaly at 4.5m depth, precisely located at 00°50'16.8" S / 117°18'24.3" E. This

distinct feature strongly indicates a collapsed structure on the riverbed. While side-scan sonar imagery (complementary to this data) would confirm its exact morphology, the identified obstruction necessitates a relocation recommendation for the associated navigation aid to ensure maritime safety and prevent hazards in the Mahakam River Delta.

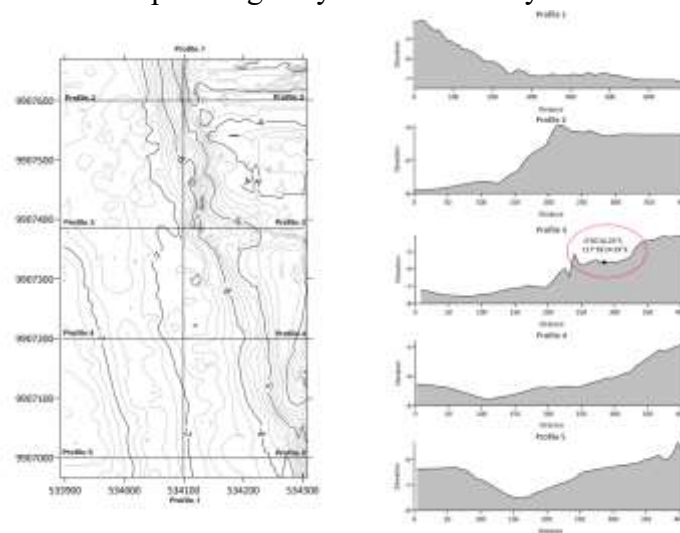
Figure 11. Recommendation for rebuilding position of navigation safety structure

Bathymetric maps and profiles revealed a significant submerged anomaly, indicating a collapsed structure (e.g., beacon) at  $0^{\circ}50'13.29''$  S /  $117^{\circ}18'24.51''$  E. Side-scan sonar would confirm its precise nature. This structure poses a serious navigational hazard. Consequently, beacon repositioning to a safer location ( $0^{\circ}50'16.29''$  S /  $117^{\circ}18'24.59''$  E) is recommended. The integrated use of bathymetry and side-scan sonar is crucial for effective hazard identification and infrastructure planning in dynamic waterways like the Mahakam River Delta.
